REVISED WETLAND DELINEATION REPORT

LAKE VILLA APARTMENTS

LAKE VILLA TOWNSHIP, LAKE COUNTY, ILLINOIS

Date Revised: June 11, 2019

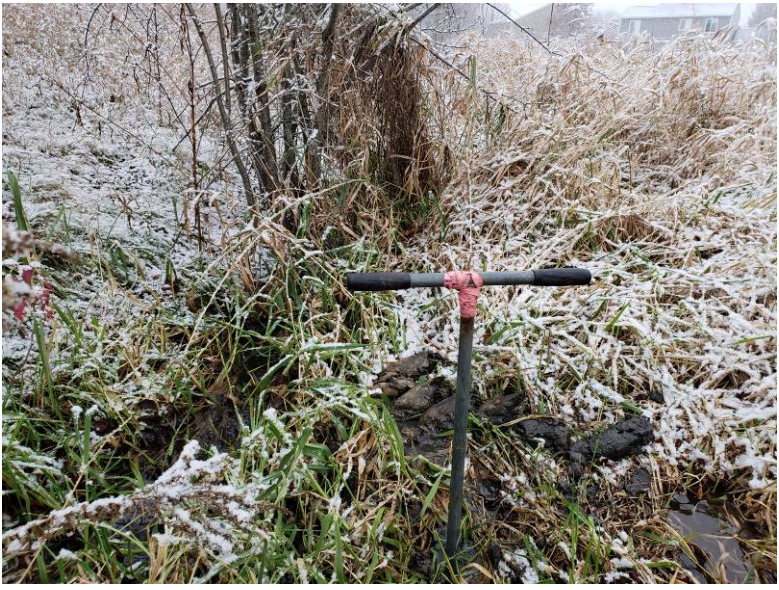
PHOTOGRAPH 1	
<p>DESCRIPTION:</p> <p>Lake Villa Apartments / W-T Group</p> <p>Wetland 1 Sample Point A (Off-Site)</p> <p>Facing South</p>

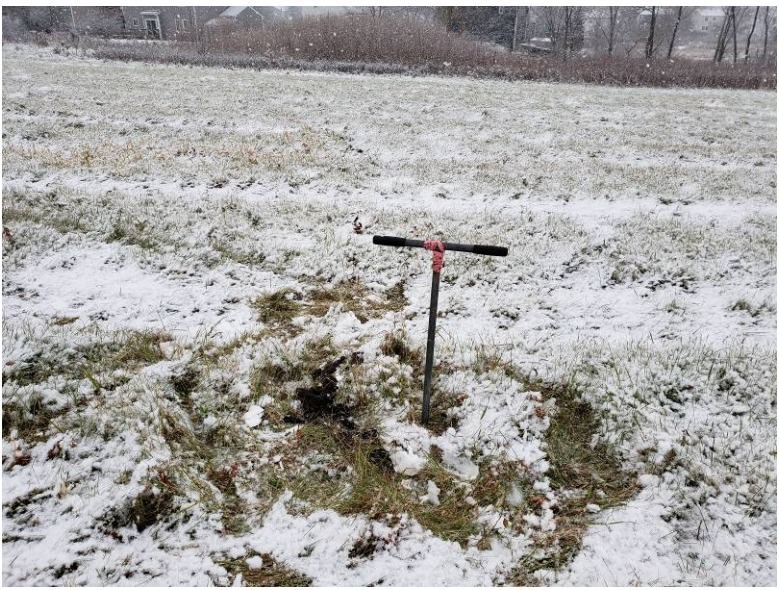
PHOTOGRAPH 2	
<p>DESCRIPTION:</p> <p>Lake Villa Apartments / W-T Group</p> <p>Wetland 1- Upland Sample Point B</p> <p>Facing South</p>

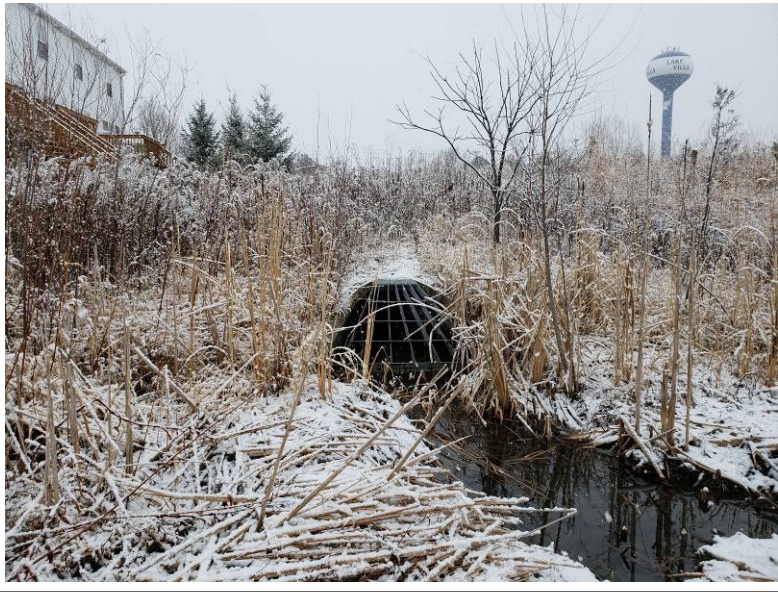
PHOTOGRAPH 5

DESCRIPTION: Lake Villa Apartments / W-T Group Culvert connecting to Wetland 1 (west side of site) Facing Northeast	
DATE PHOTO TAKEN: November 15, 2018

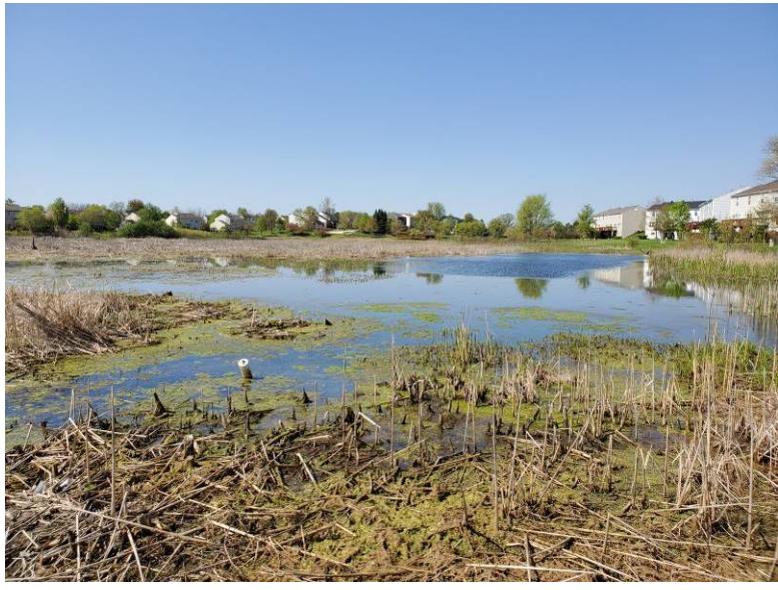
PHOTOGRAPH 7

DESCRIPTION: Lake Villa Apartments / W-T Group Wetland 1 Overview Facing Southwest	
DATE PHOTO TAKEN: May 15, 2019

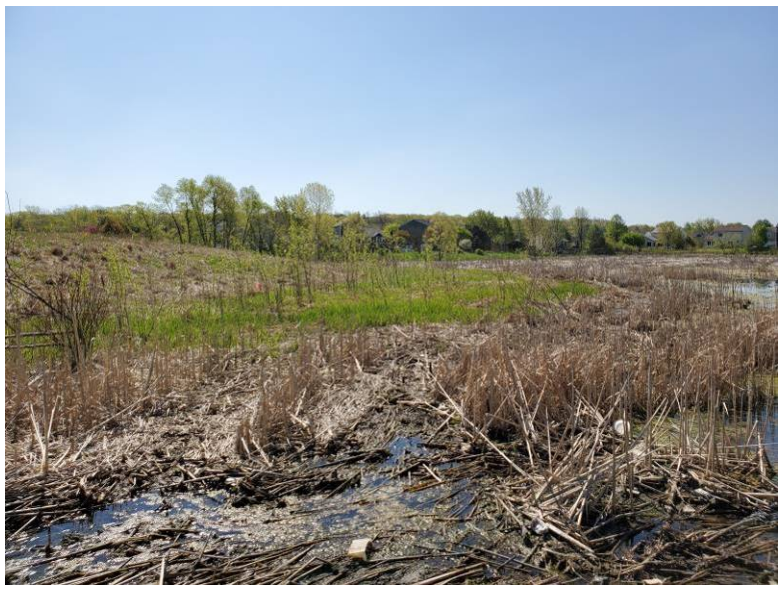
PHOTOGRAPH 8

DESCRIPTION: Lake Villa Apartments / W-T Group Wetland 1 Overview (Off-Site) Facing East	
DATE PHOTO TAKEN: May 15, 2019

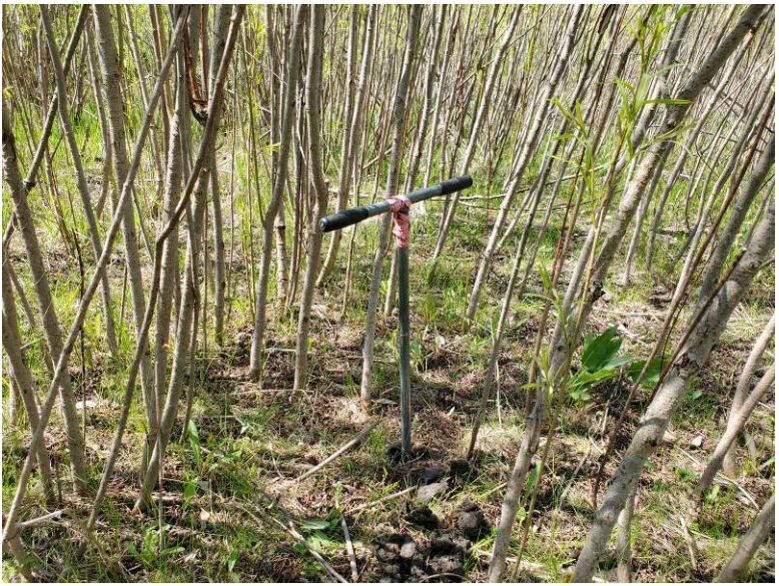
PHOTOGRAPH 10	
DESCRIPTION: Lake Villa Apartments / W-T Group Wetland 1 – Upland Sample Point H (Off-Site) Facing North

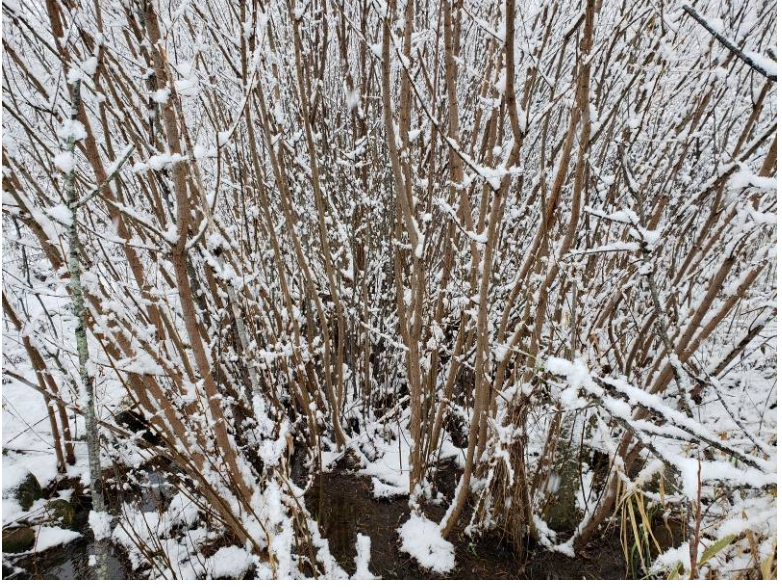
PHOTOGRAPH 11	
DESCRIPTION: Lake Villa Apartments / W-T Group Wetland 1 Overview (Off-Site) Facing South

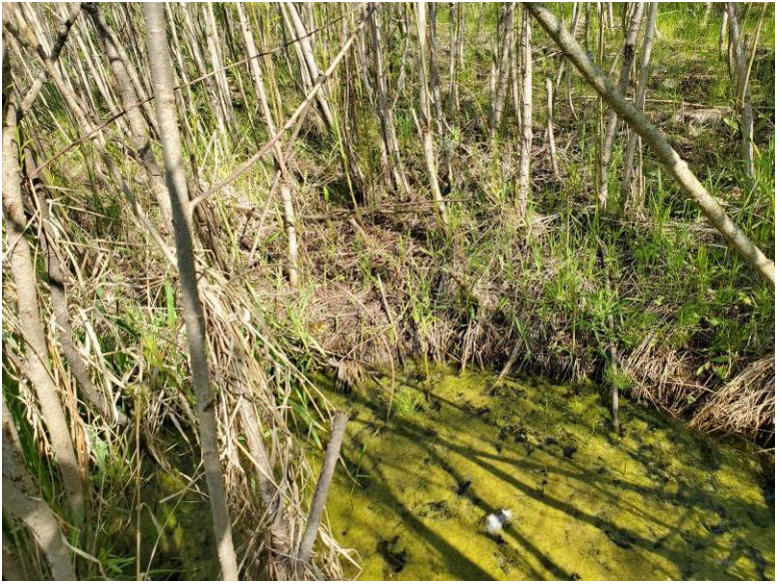
PHOTOGRAPH 12	
DESCRIPTION: Lake Villa Apartments / W-T Group Wetland 1 Overview (Off-Site) Facing North

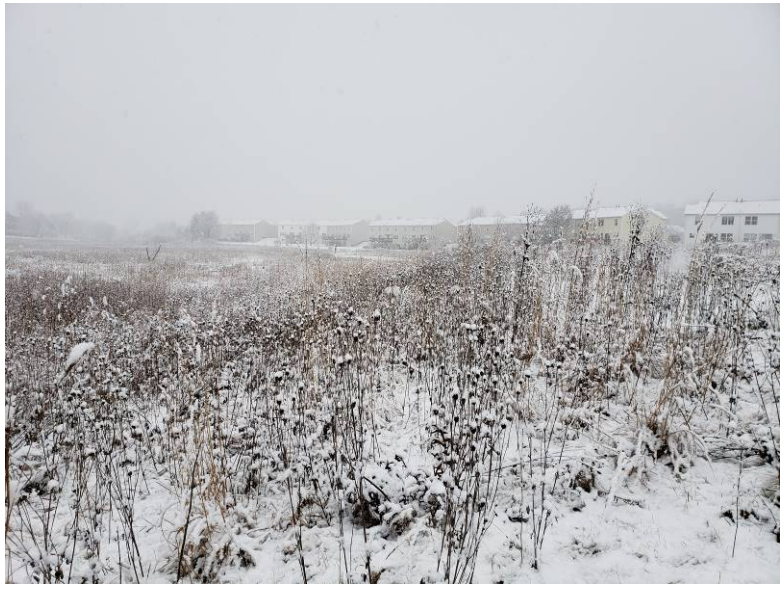
PHOTOGRAPH 13

DESCRIPTION: Lake Villa Apartments / W-T Group Site Overview, Wetland 1 Upland-Prairie Buffer Facing Southwest	
DATE PHOTO TAKEN: November 15, 2018

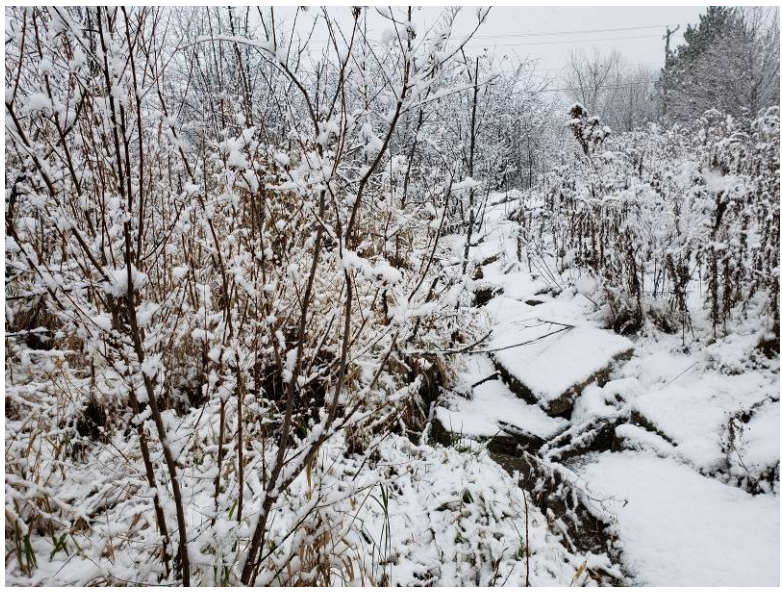
PHOTOGRAPH 14

DESCRIPTION: Lake Villa Apartments / W-T Group Wetland 1 Overview (Off-Site) Facing East	
DATE PHOTO TAKEN: November 15, 2018

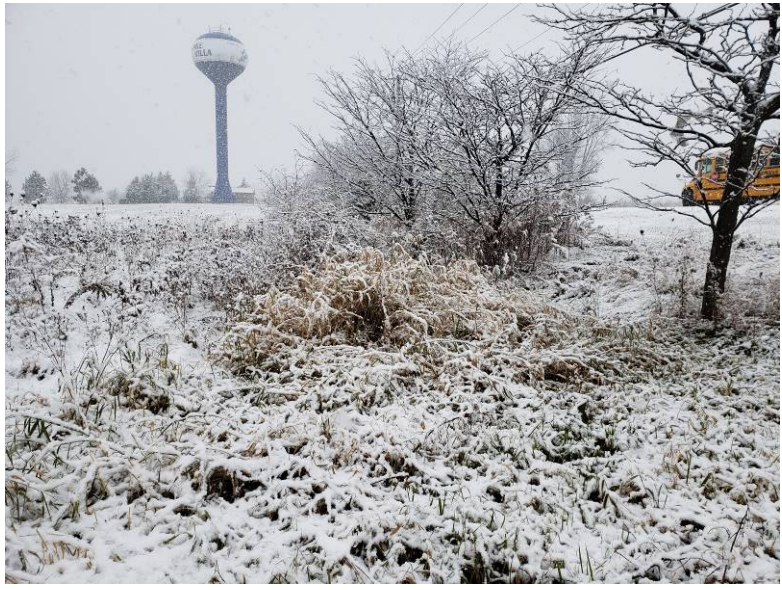
PHOTOGRAPH 15	
DESCRIPTION: Lake Villa Apartments / W-T Group Wetland 1 Overview (Off-Site) Facing North

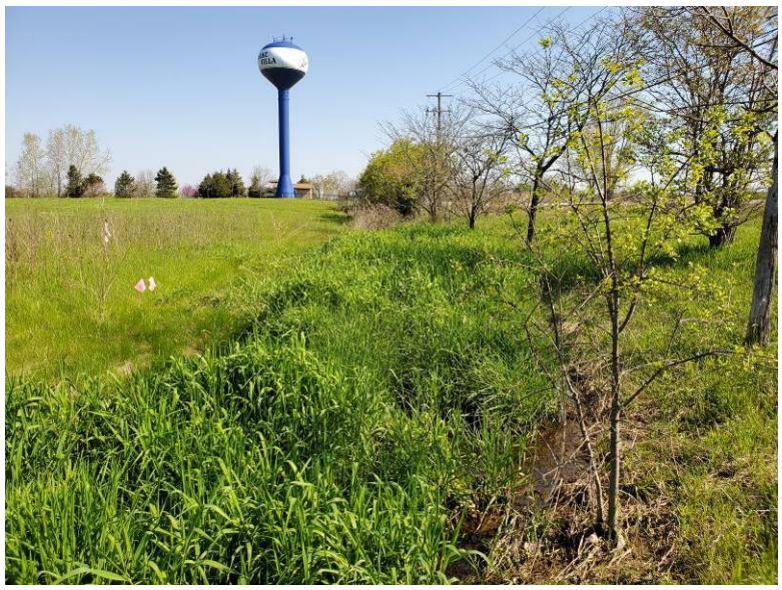
PHOTOGRAPH 16	
DESCRIPTION: Lake Villa Apartments / W-T Group Wetland 1 Overview (Off-Site) Facing North

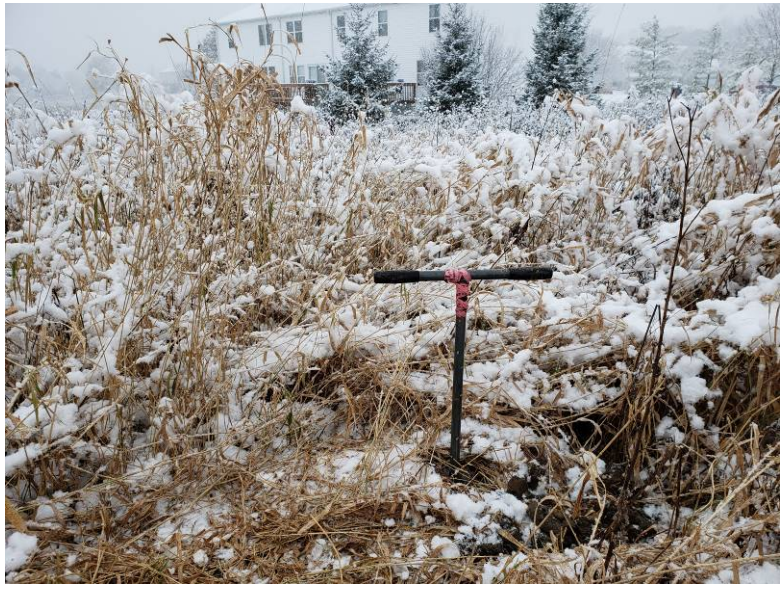
PHOTOGRAPH 19

DESCRIPTION: Lake Villa Apartments / W-T Group Investigated Area 1, Sample Point E Facing West	
DATE PHOTO TAKEN: November 15, 2018

Investigated Area 1 was primarily vegetated by Reed Canary Grass (*Phalaris arundinacea*). The mapped soil series is Zurich and Ozaukee silt loams, 4 to 6 percent slopes, eroded (840C2), a non-hydric soil. USDA field indicators F6: Redox Dark Surface and F7: Depleted Dark Surface provided evidence of hydric soil. Evidence of persistent hydrology was not observed (See Wetland Determination Data Forms).

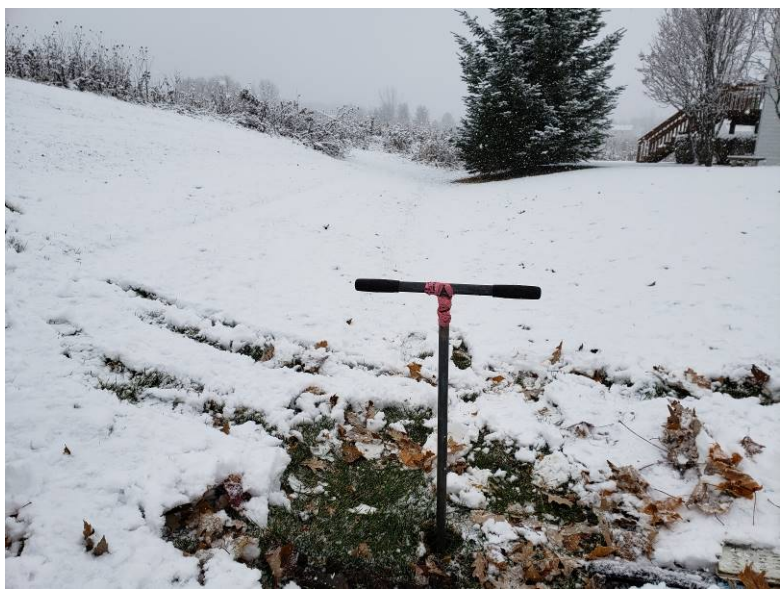
PHOTOGRAPH 20

DESCRIPTION: Lake Villa Apartments / W-T Group Investigated Area 2, Sample Point F Facing Southwest	
DATE PHOTO TAKEN: November 15, 2018

The on-site portion of Investigated Area 2 was primarily vegetated by Kentucky Blue Grass (*Poa pratensis*). The mapped soil series is Grays and Markham silt loams, 2 to 4 percent slopes (979B), a non-hydric soil. USDA field indicators F6: Redox Dark Surface and F7: Depleted Dark Surface provided evidence of hydric soil. Evidence of persistent hydrology was not observed (See Wetland Determination Data Forms).

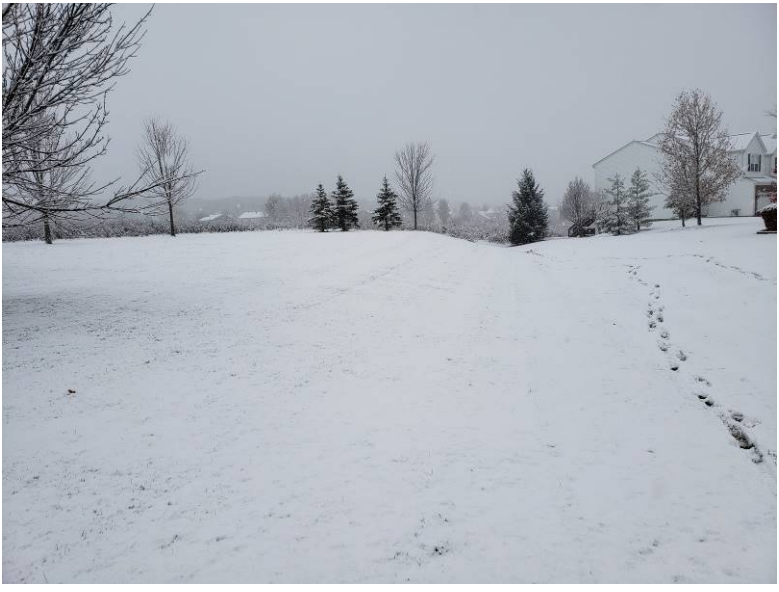
PHOTOGRAPH 21

DESCRIPTION: Lake Villa Apartments / W-T Group Investigated Area 2 Overview Facing Southwest	
DATE PHOTO TAKEN: November 15, 2018

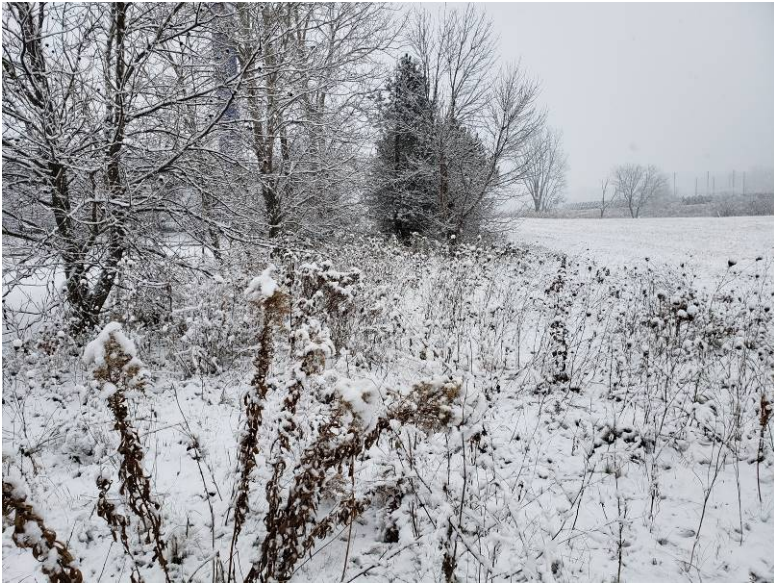
PHOTOGRAPH 24	
DESCRIPTION: Lake Villa Apartments / W-T Group Site Overview, Northern Boundary Facing East

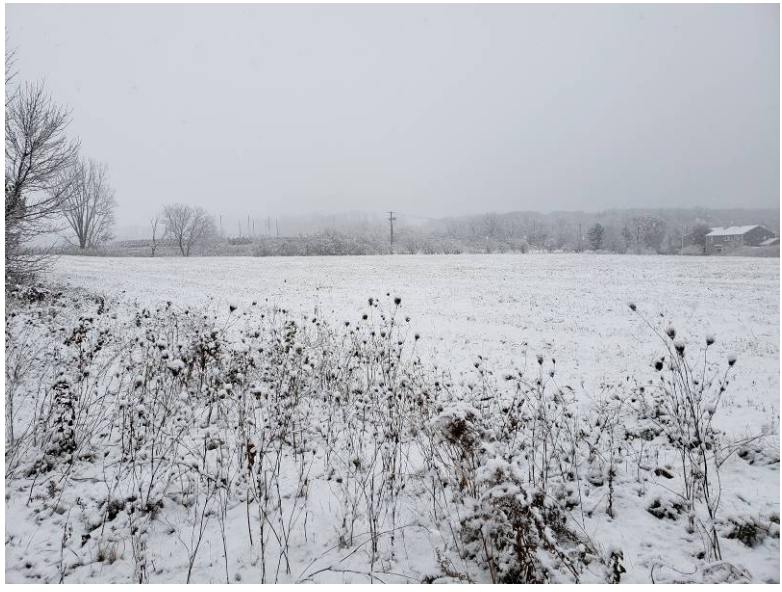
PHOTOGRAPH 25

DESCRIPTION: Lake Villa Apartments / W-T Group Site Overview Facing Southeast	
DATE PHOTO TAKEN: November 15, 2018

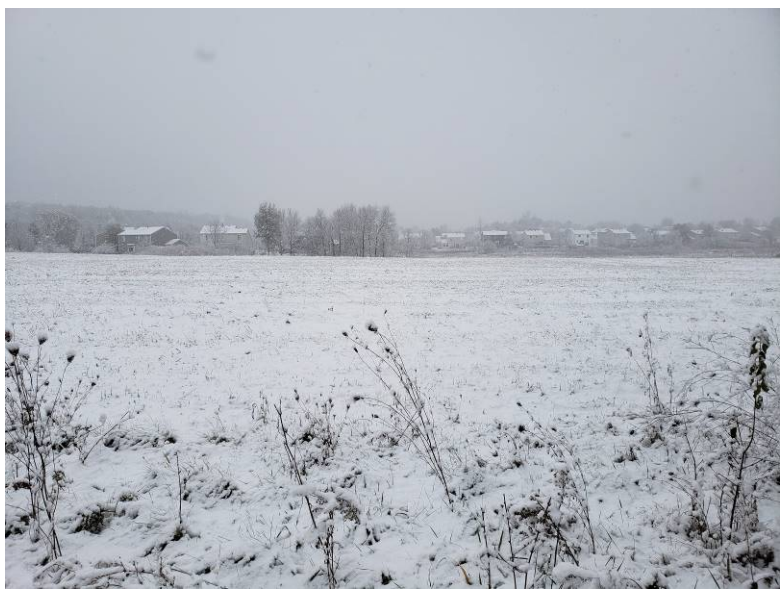
PHOTOGRAPH 26

DESCRIPTION: Lake Villa Apartments / W-T Group Site Overview Facing South	
DATE PHOTO TAKEN: November 15, 2018

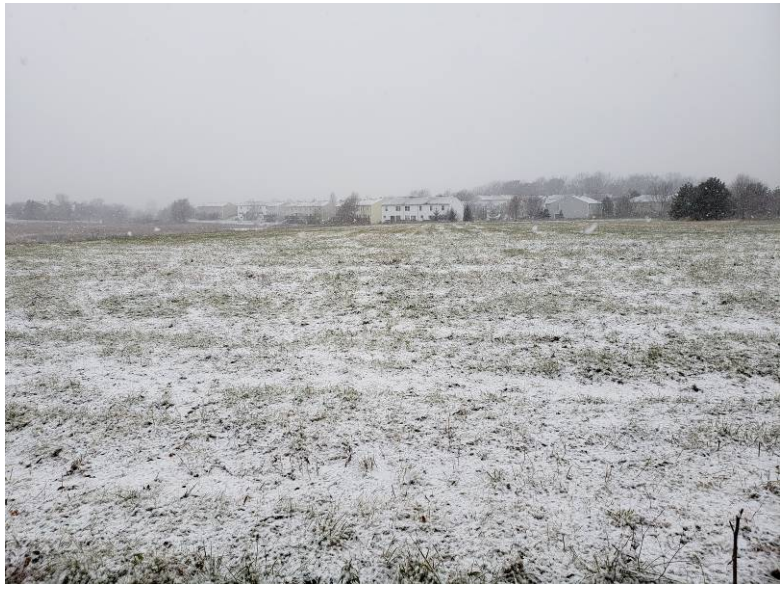
PHOTOGRAPH 27

DESCRIPTION: Lake Villa Apartments / W-T Group Site Overview Facing West	
DATE PHOTO TAKEN: November 15, 2018

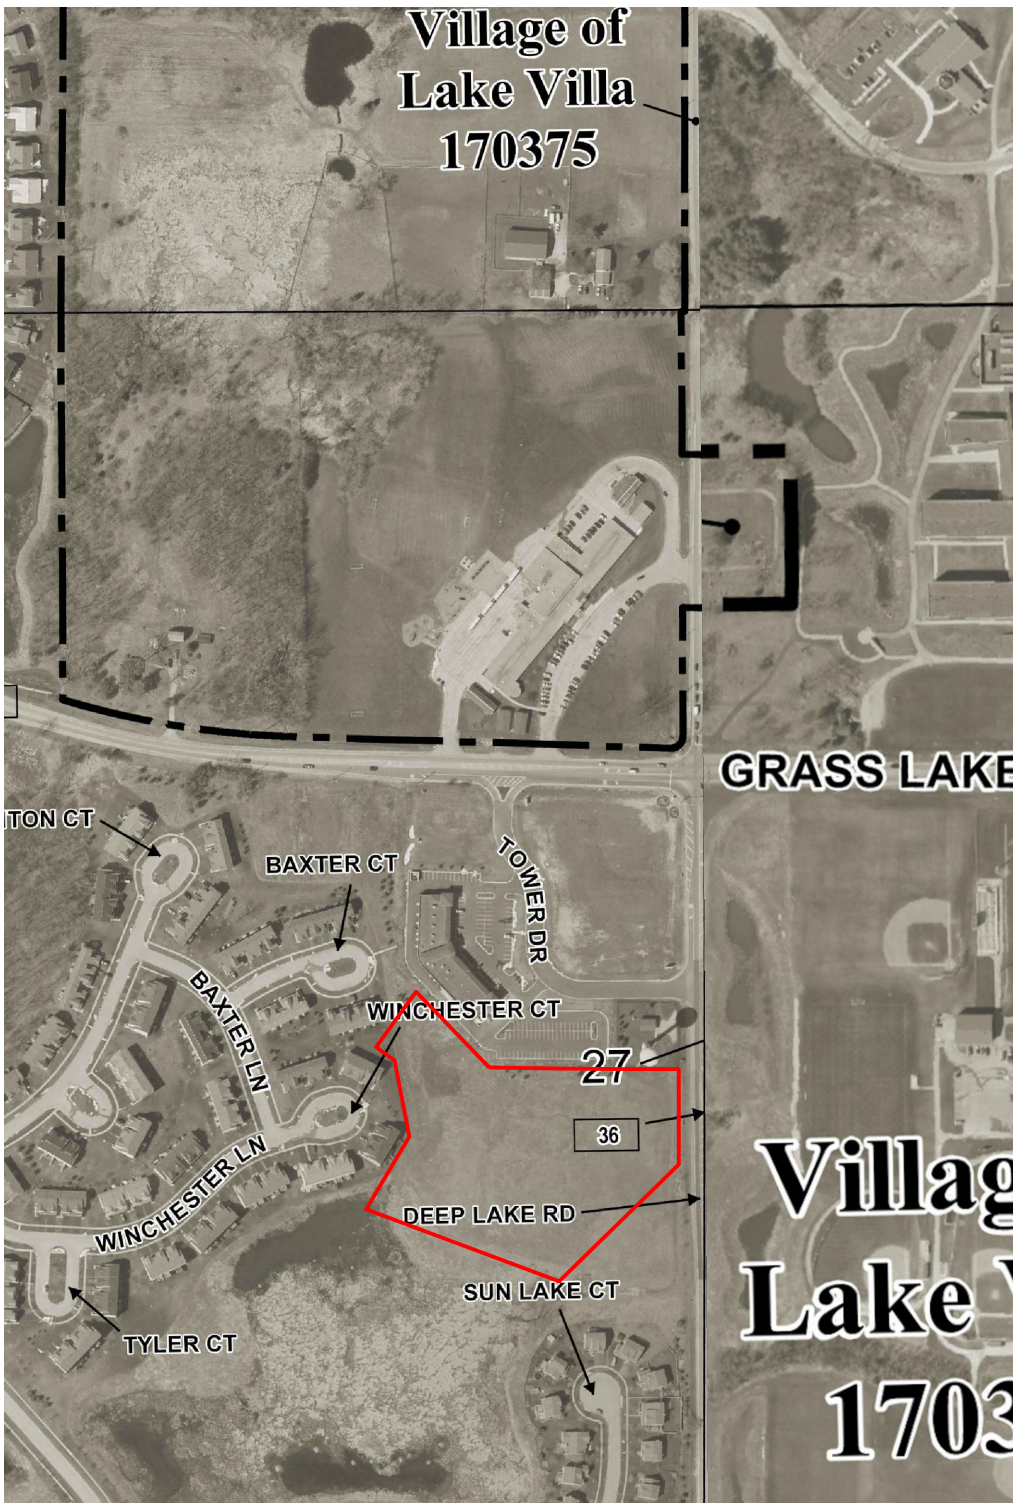
Exhibit E

SPECIAL FLOOD HAZARD AREAS (SFHAs) SUBJECT TO INUNDATION BY THE 1% ANNUAL CHANCE FLOOD
The 1% annual chance flood (100-year flood), also known as the base flood, is the flood that has a 1% chance of being equaled or exceeded in any given year. The Special Flood Hazard Area is the area subject to flooding by the 1% annual chance flood. Areas of Special Flood Hazard include Zones A, AE, AH, AO, AR, AV, and VE. The Base Flood Elevation is the water-surface elevation of the 1% annual chance flood.

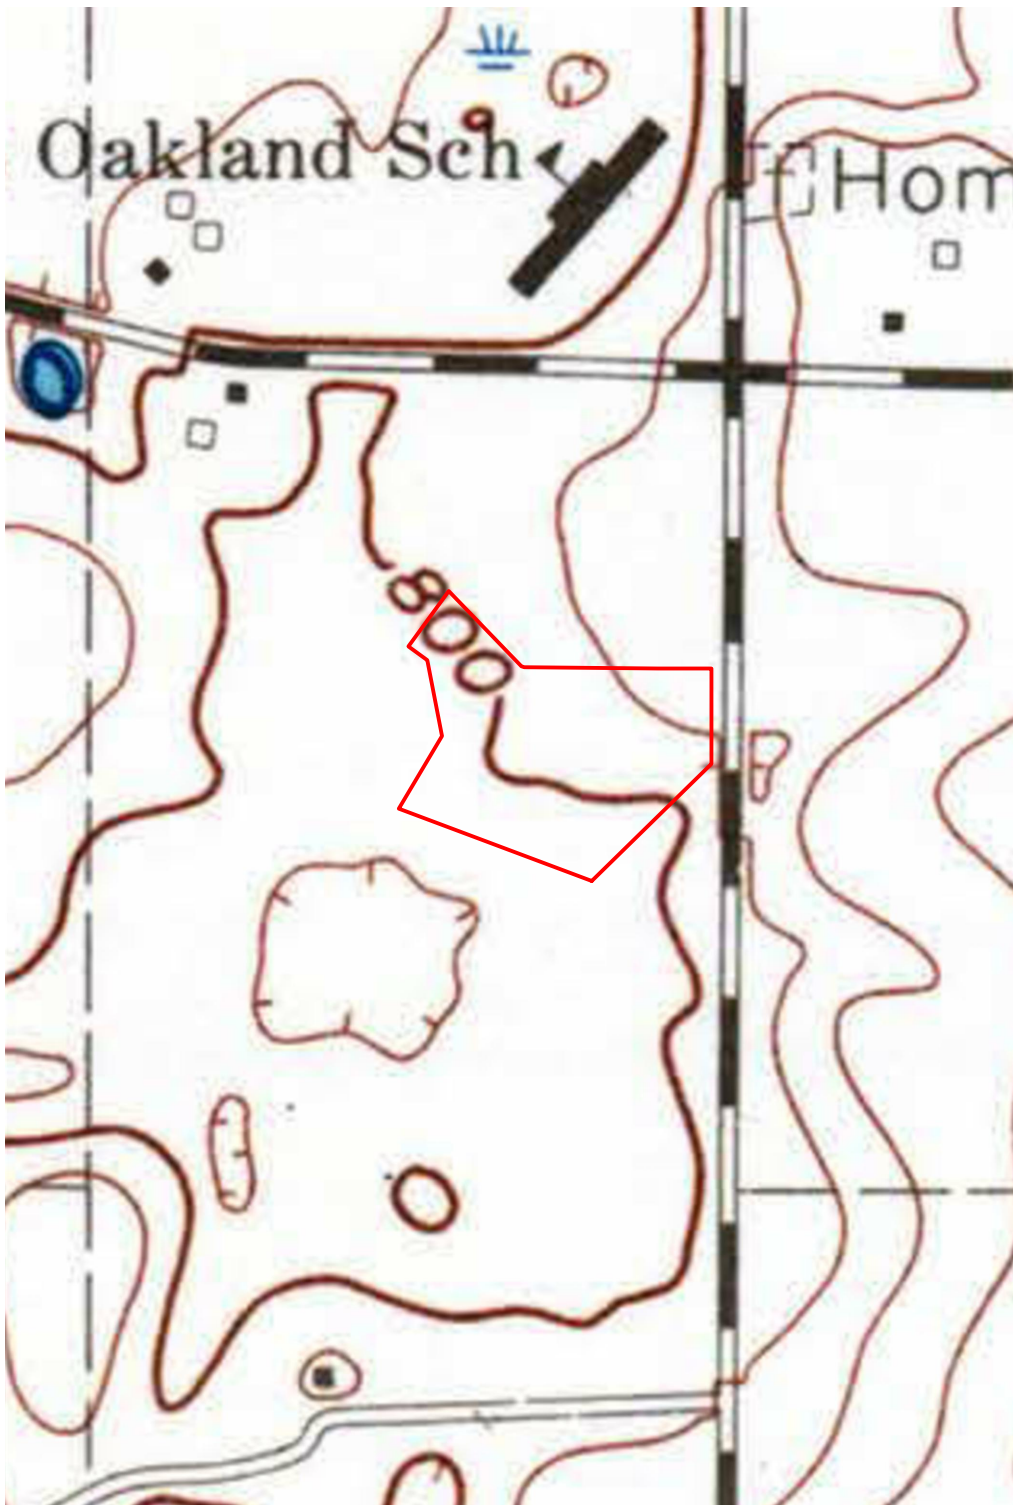
Hydrologic Atlas

- Area flooded
- Boundary of 1965 flood 1965
- Boundary of 1960 flood 1960
- Boundary of 1938 flood 1938
- Drainage divide
- River mile measured along stream channel X (5)
- Inundated areas defined for different floods, upstream and downstream 1965 → 1960

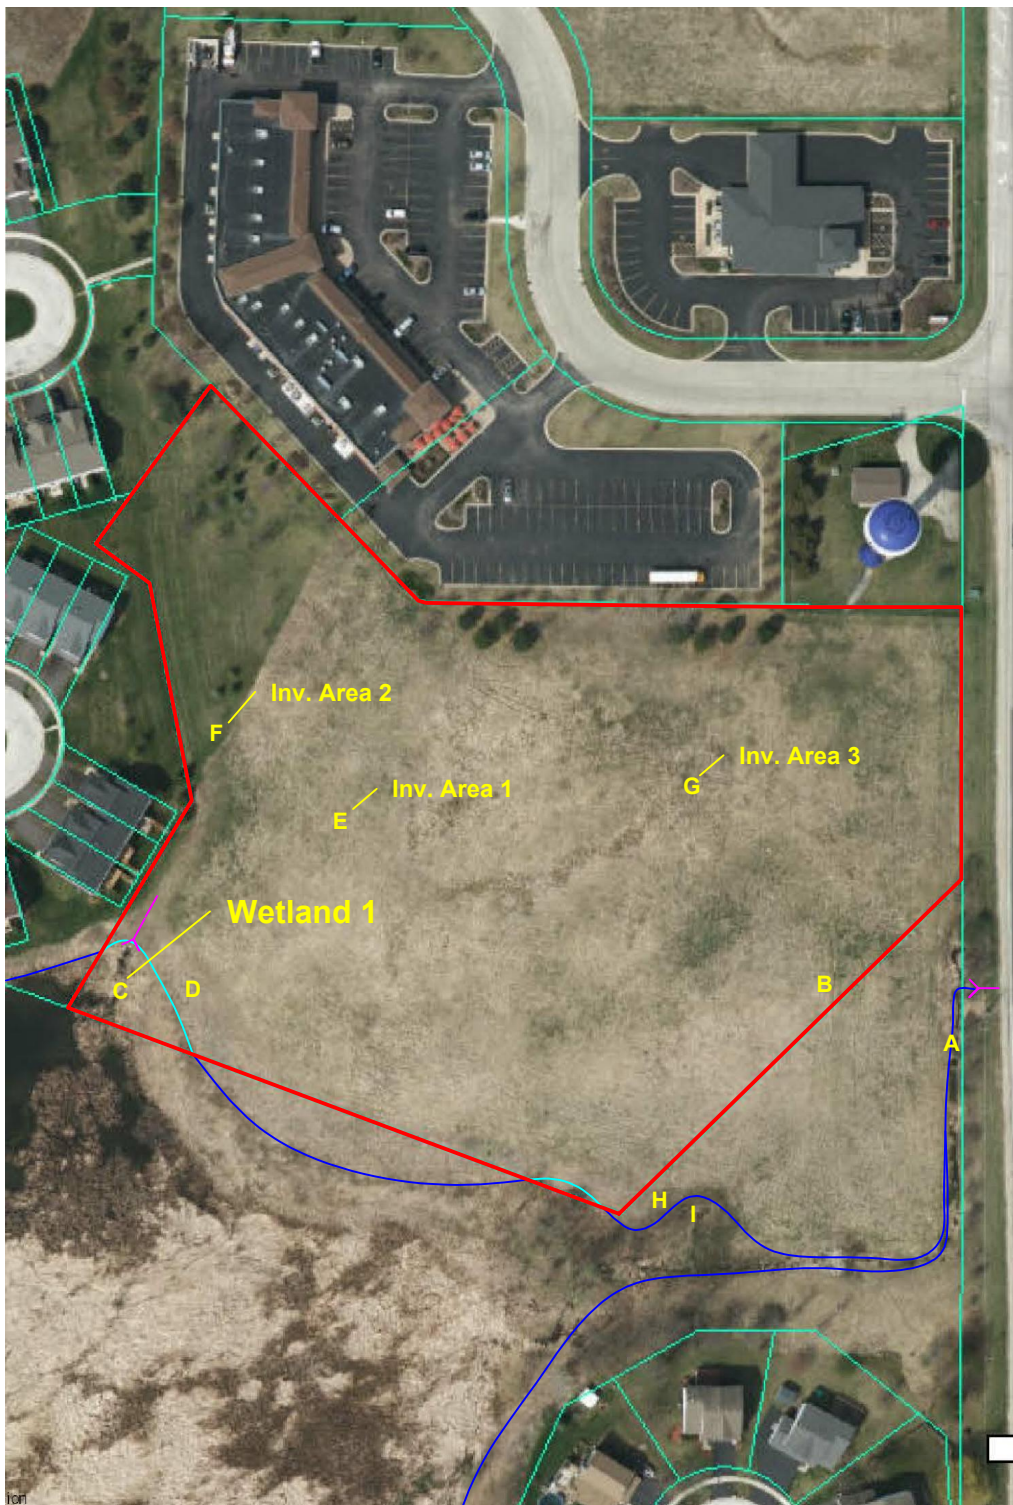
Aerial Photograph

- Project Area —
- Approximate On-site Wetland Boundary —
- Approximate Off-site Wetland Boundary —
- Sample Points A-I
- Culvert ⌵

One wetland totaling approximately 11 acres (approximately 0.093 acres on-site) was identified extending onto the project area. Wetland boundaries were identified and staked using methods sanctioned by the United States Army Corps of Engineers. Wetland acreages provided in this report are estimations; a survey of the staked wetland boundaries must be performed in order to obtain exact size and location information.
